CSTO

Table 1. Presenting symptoms of Band Erosion

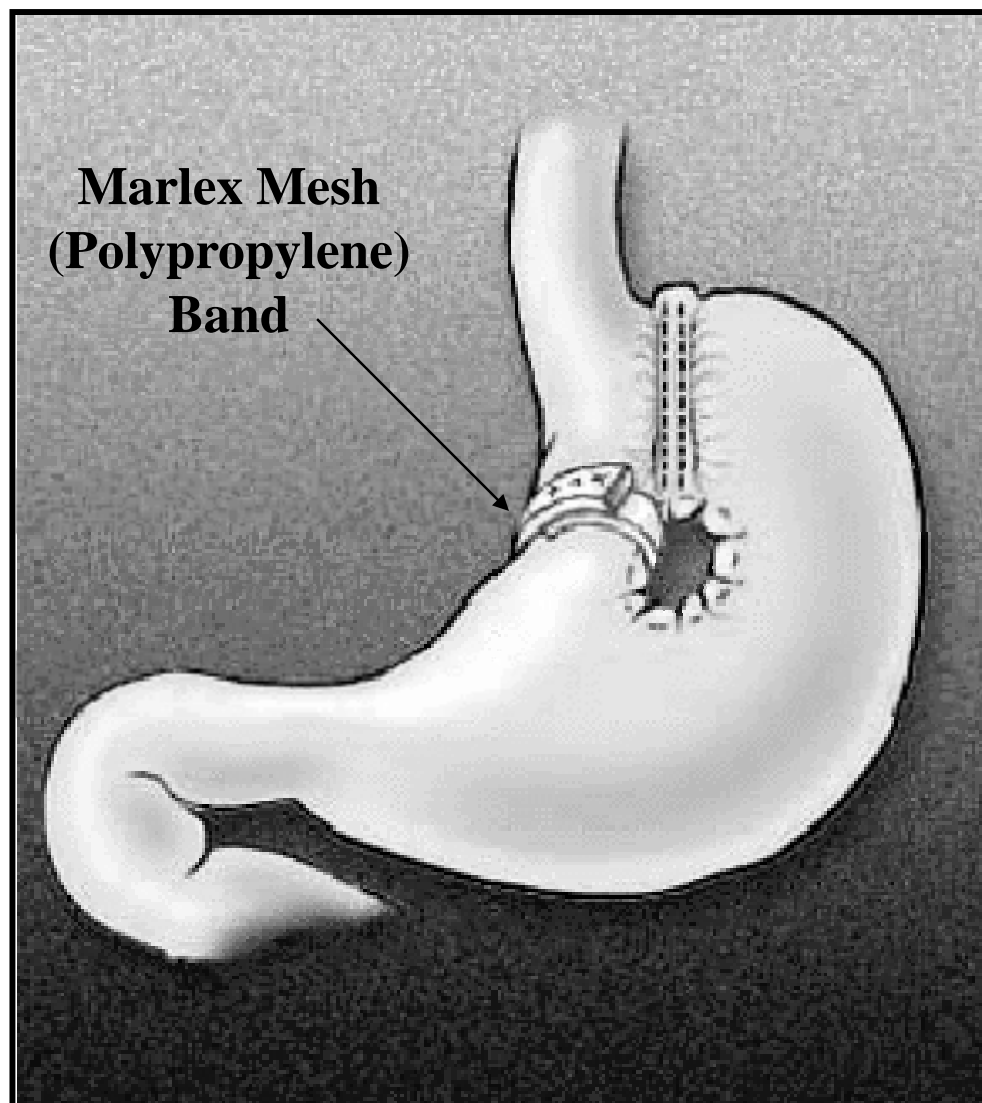
Fig.2: Vertical Banded Gastroplasty (VBG) (Mason, 1980)

**Silastic
Tubular
Band**

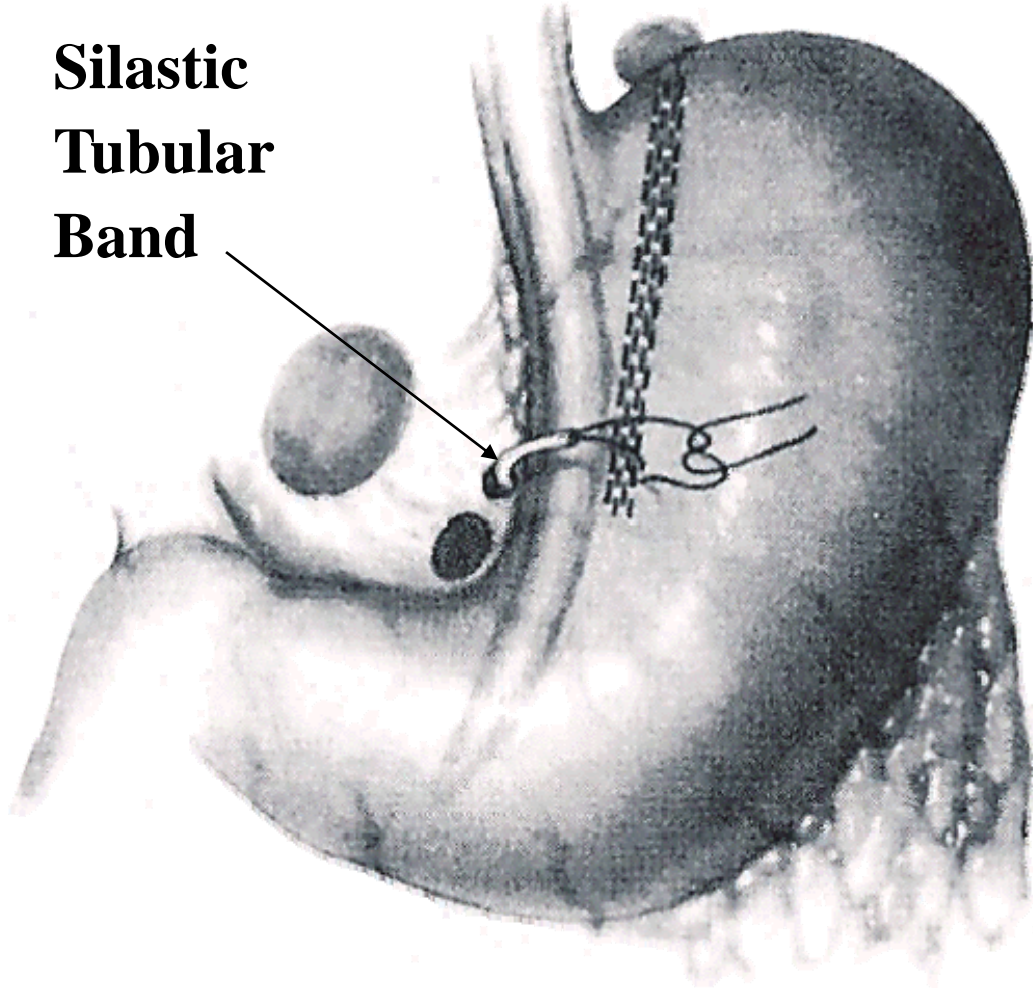
Fig.3: Vertical Ring Gastroplasty (VRG) (Laws, 1981)

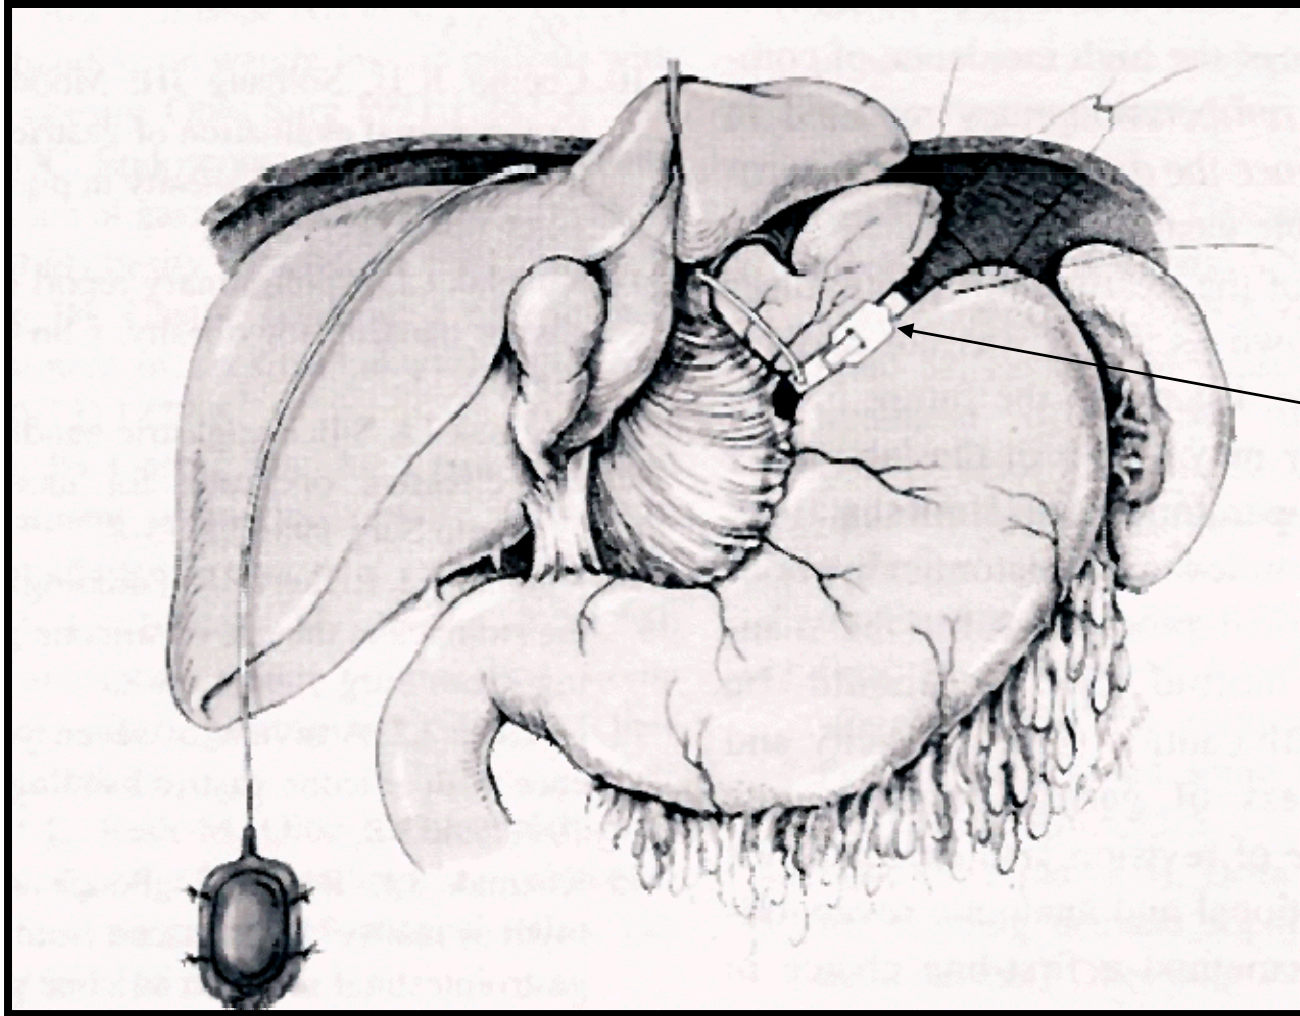
Fig.5. Inflatable Gastric Band (Kuzmak)

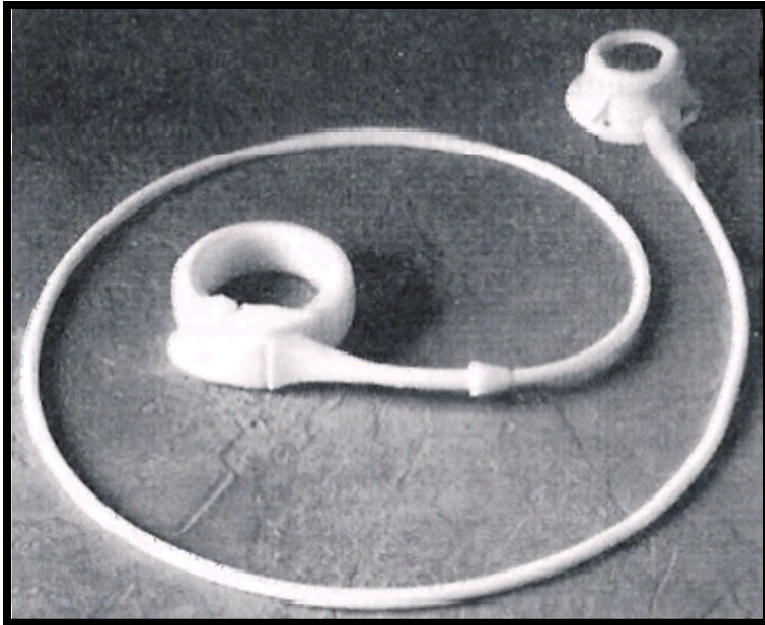
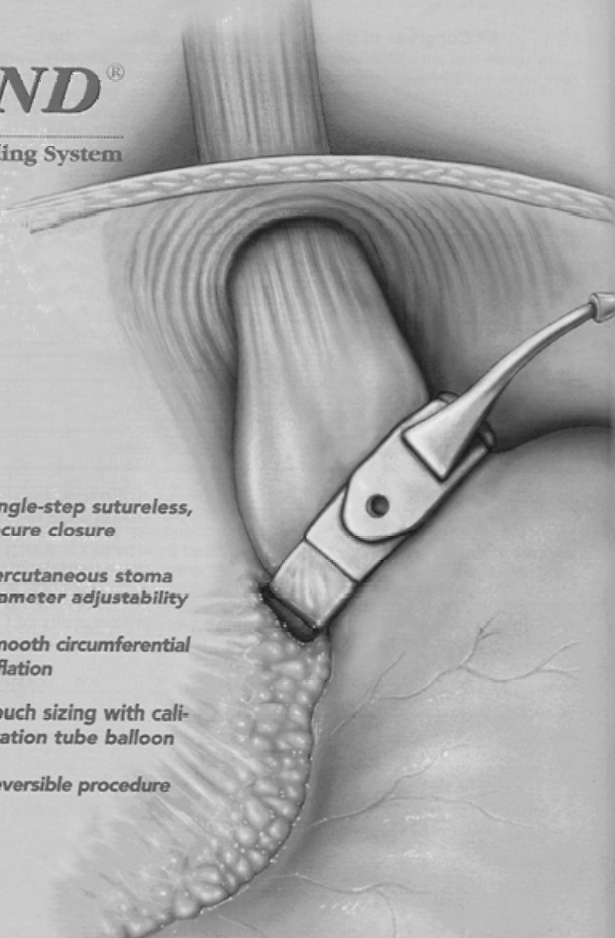
LAP-BAND[®]
Adjustable Gastric Banding System

The diagram illustrates the surgical placement of the Lap-Band around the upper part of the stomach. A surgical instrument is shown adjusting the band. A list of features is provided:

- Single-step sutureless, secure closure
- Percutaneous stoma diameter adjustability
- Smooth circumferential inflation
- Pouch sizing with calibration tube balloon
- Reversible procedure

Fig.6. Adjustable Gastric Band (Lap-Band)

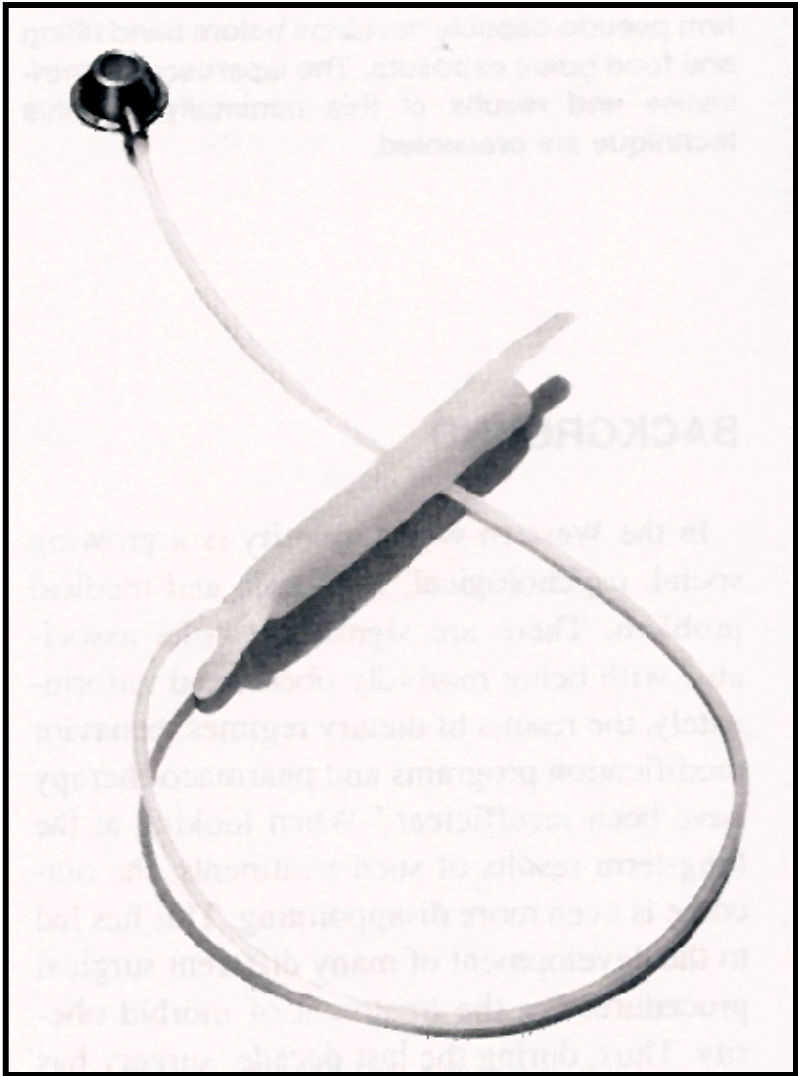
Fig.8: Swedish Adjustable Gastric Band (Obtech)

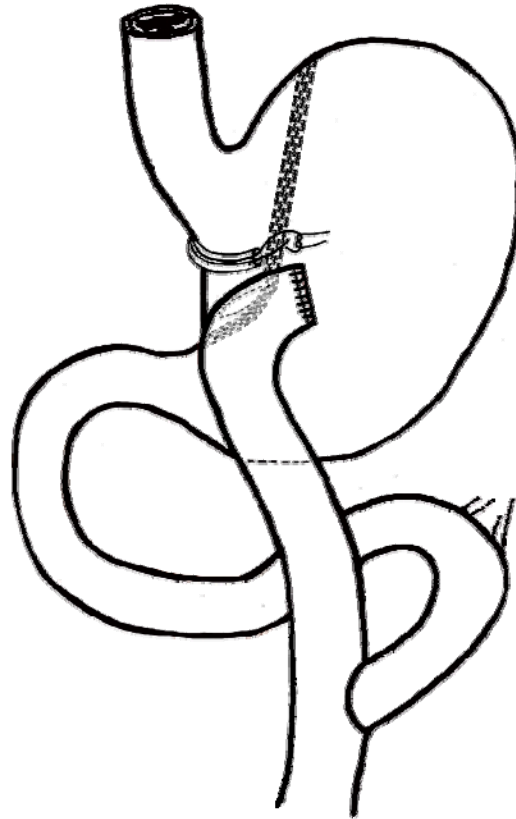
Fig. 9: Silastic Ring Vertical Banded Gastric Bypass
(SRVGBP). (Fobi 1986)

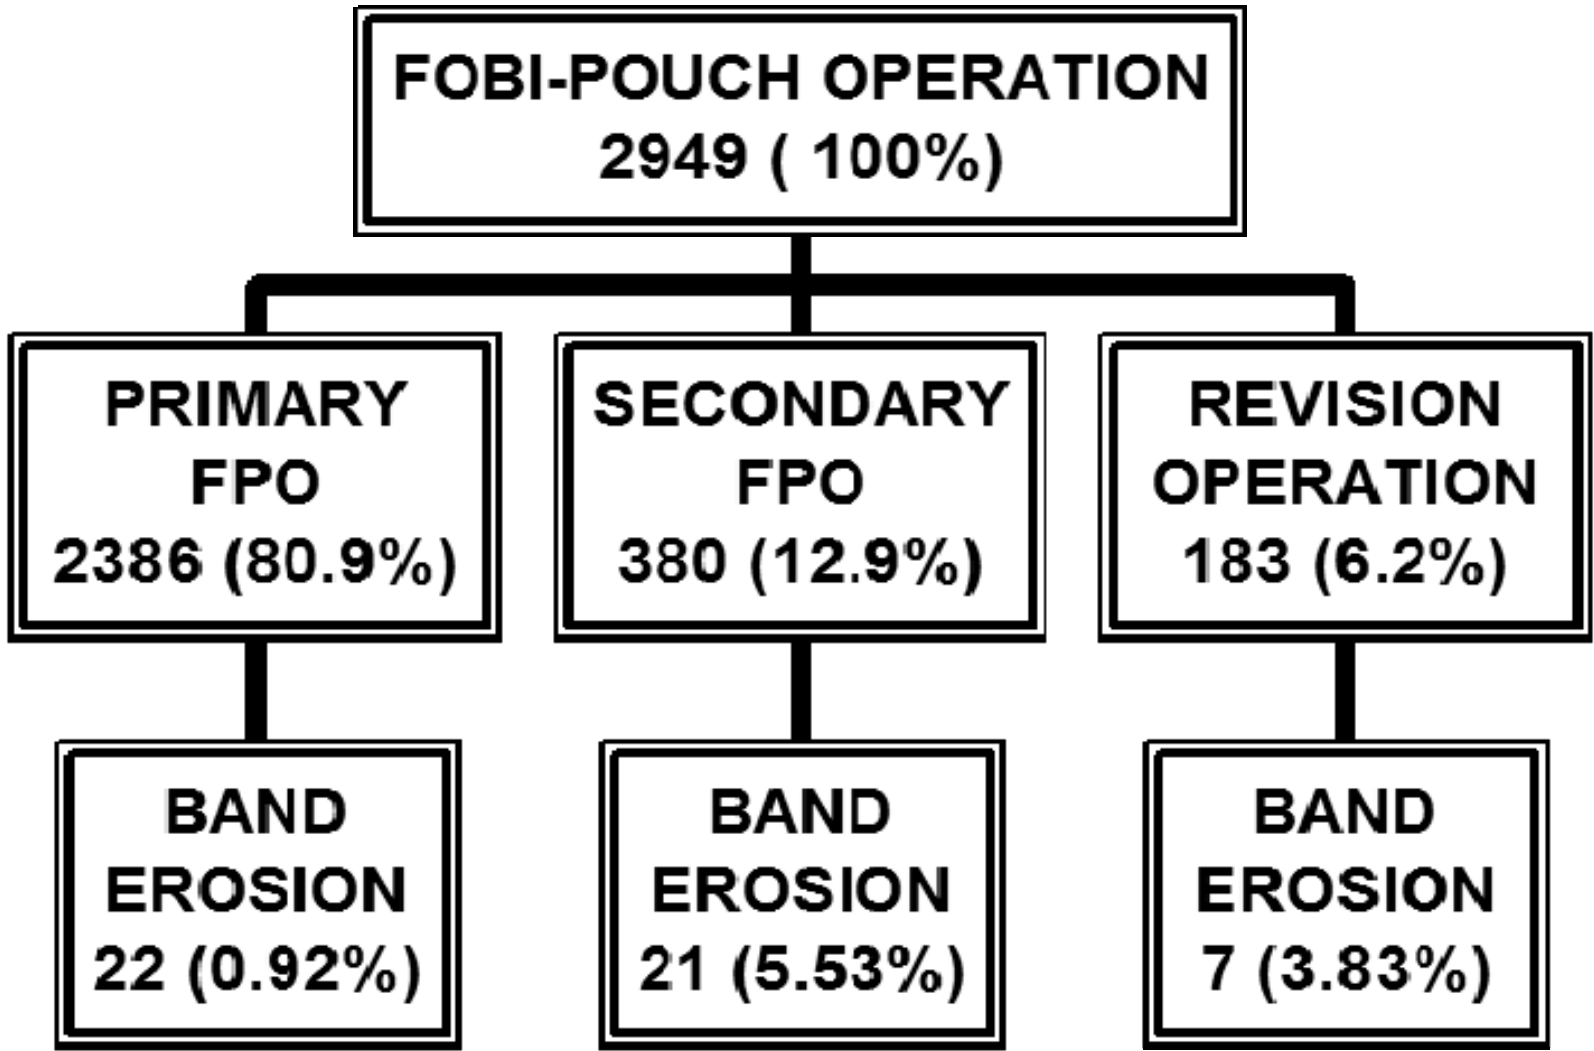
Fig.11: Incidence of Band Erosion (May 1992- May 2001).

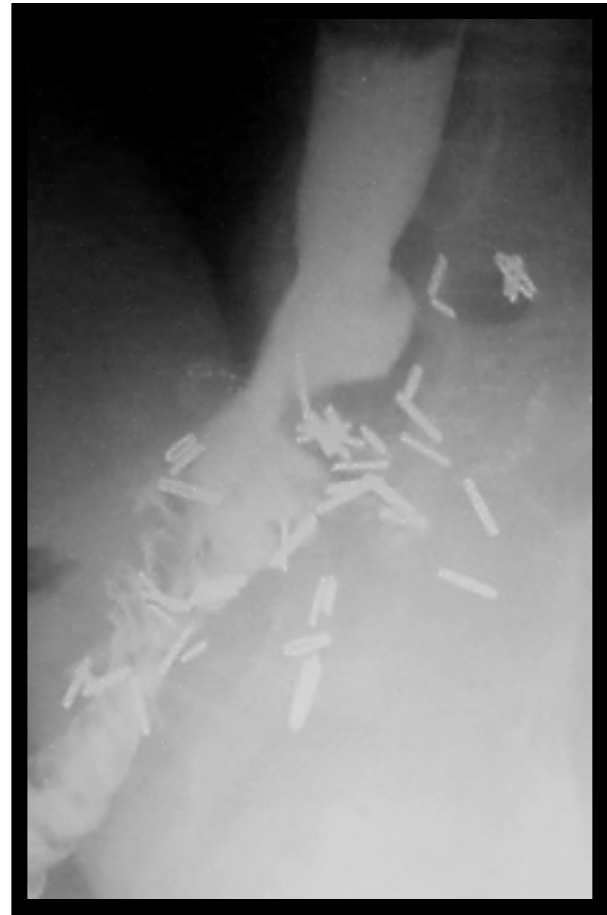
Fig.13-b: X-ray of the stoma, s/p FPO without Band Erosion

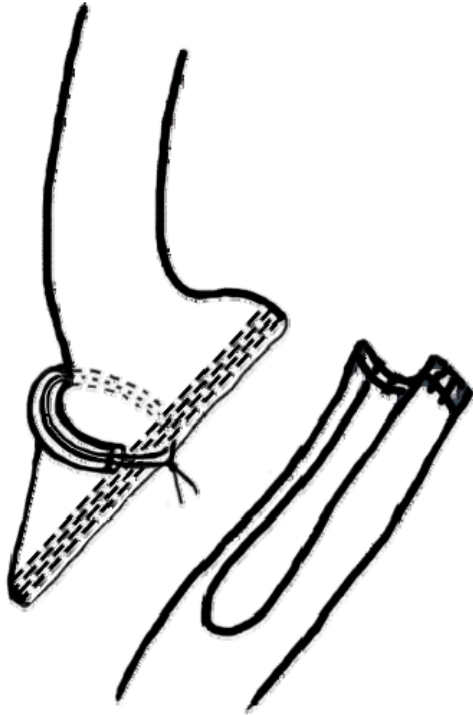
Fig.14-a: Band placement up to 1998

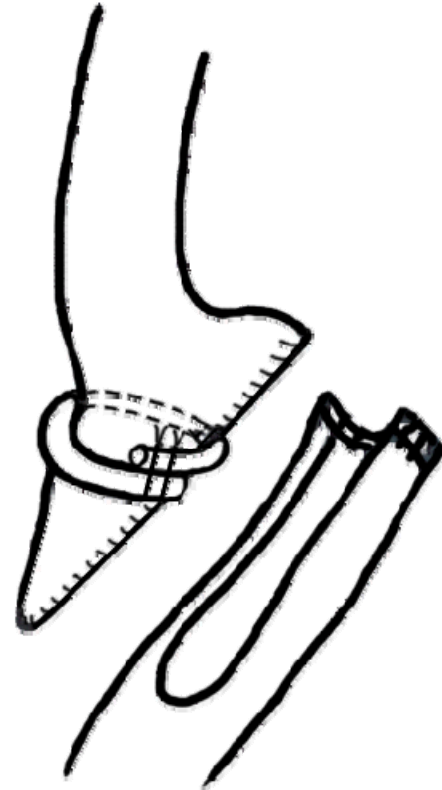
Fig.14-b: Band placement after 1998

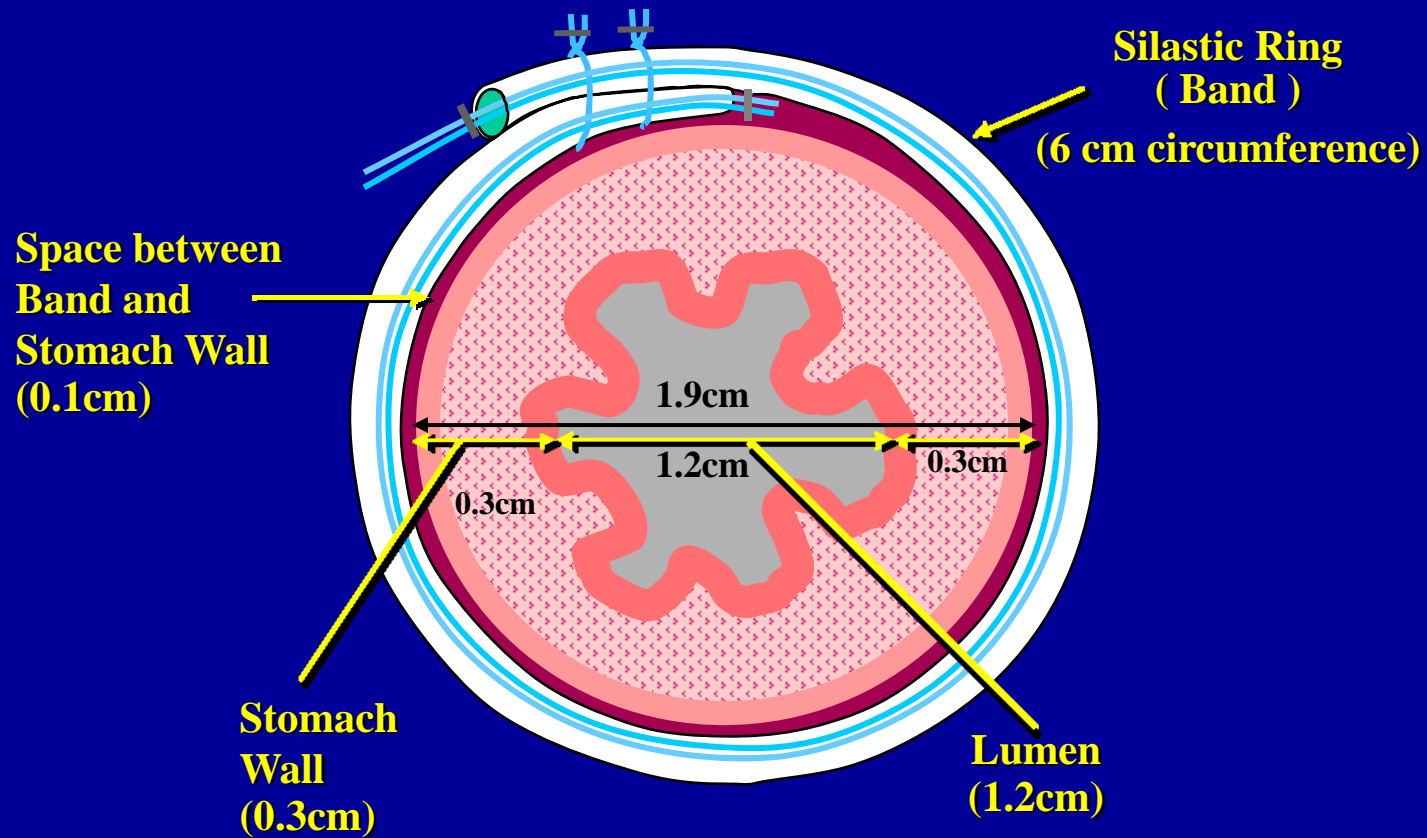
Fig. 15: Cross section of Silastic Ring Band and Pouch.

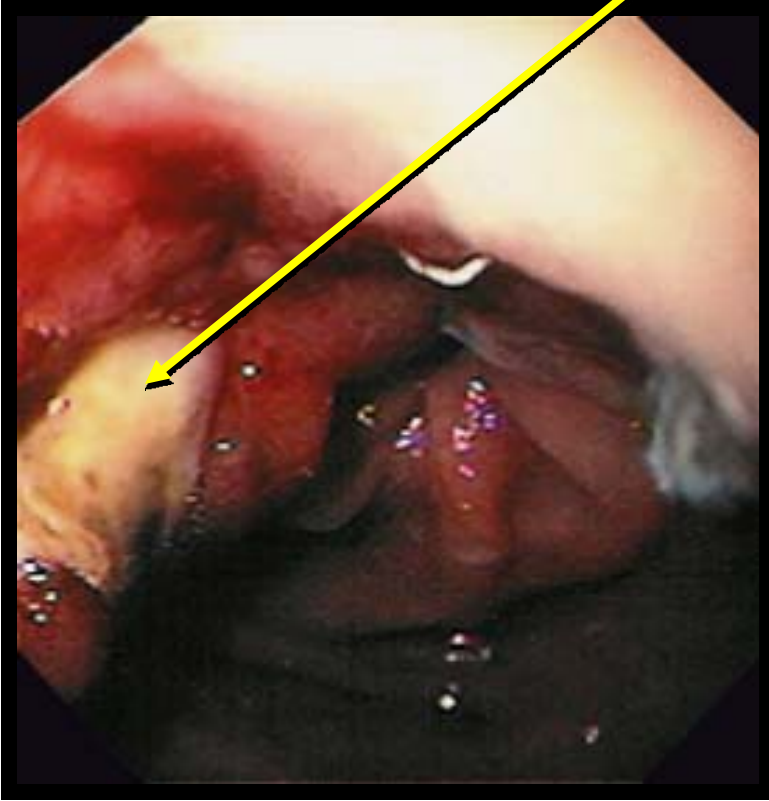
ERODED SILASTIC RING

Fig.16-a: Band Erosion - partial erosion

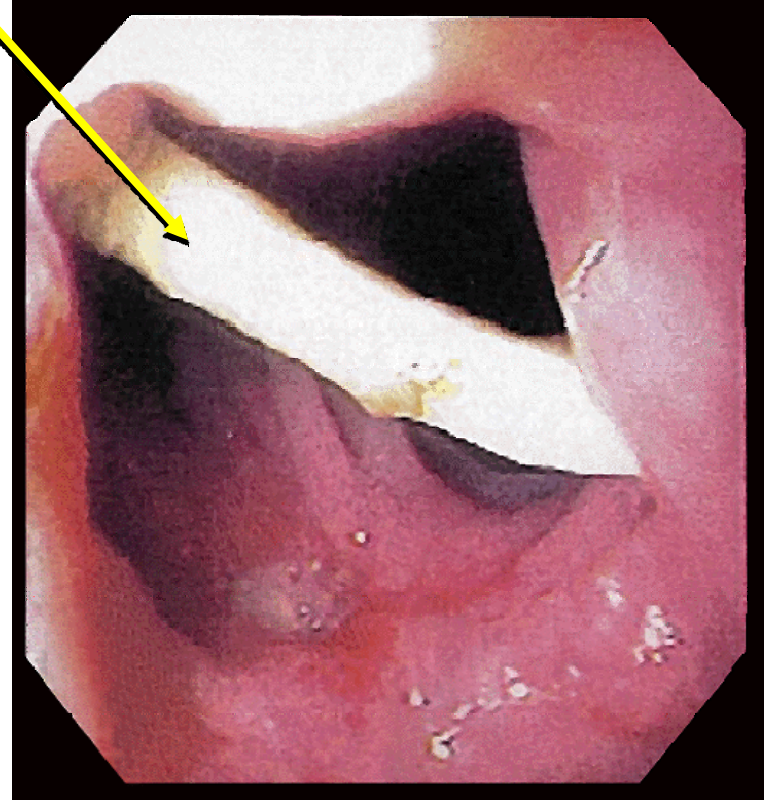
Fig.16-b: Band Erosion - complete erosion
